Ravensdown – Remediation Action Plan

For Bluehaven Management Ltd

May 2018

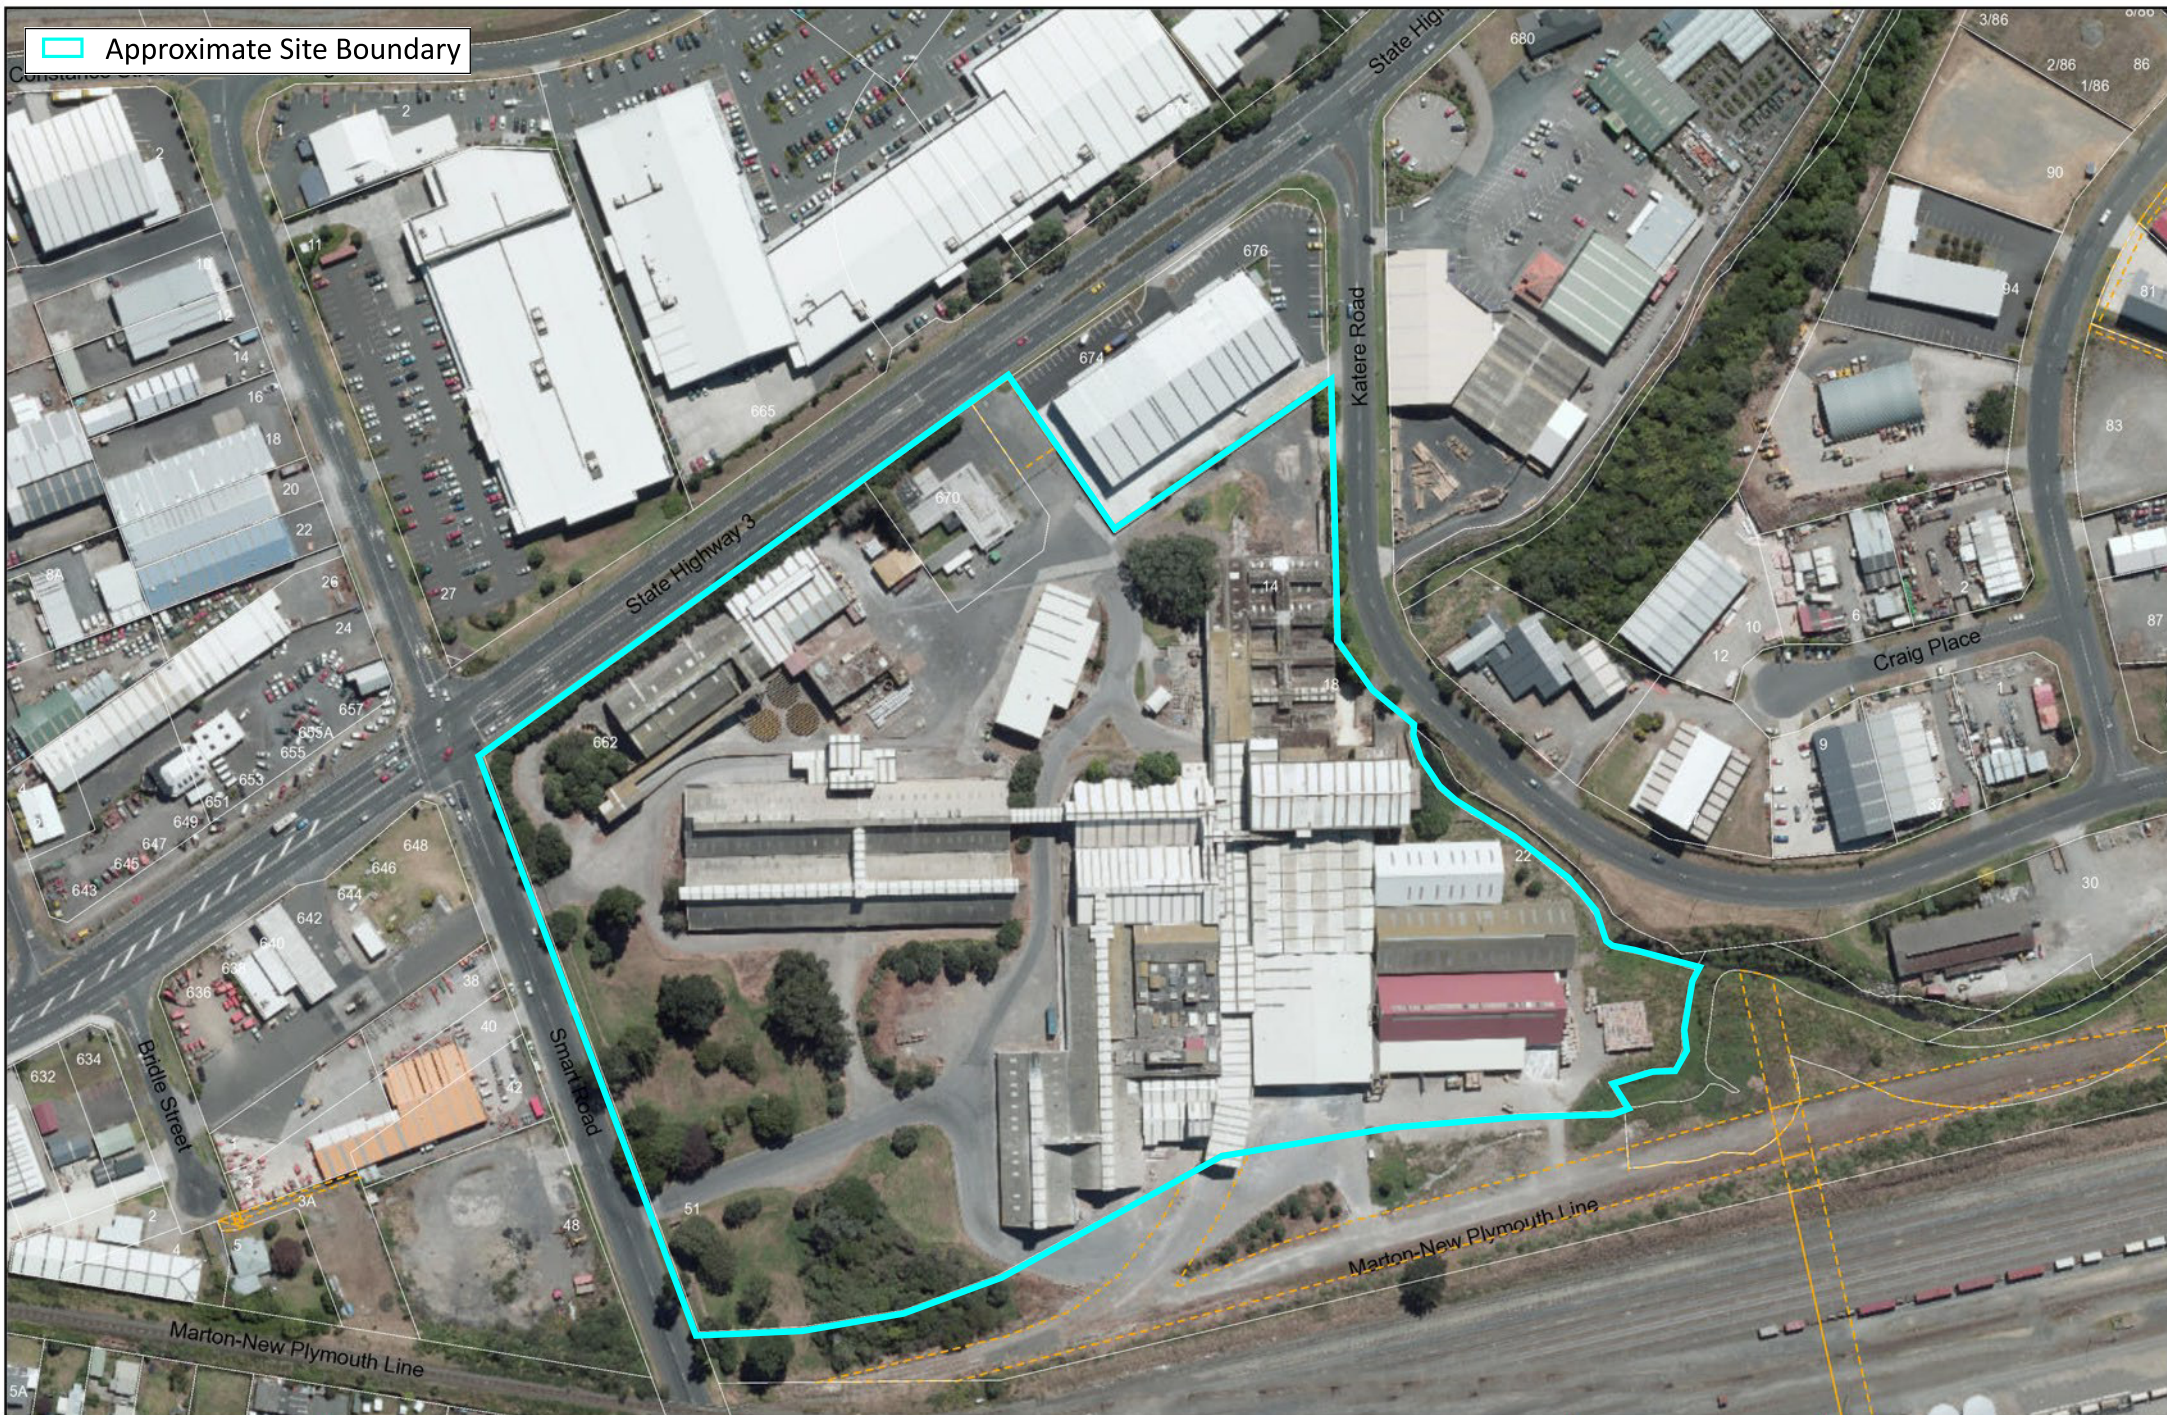
Approximate Site Boundary

Aerial imagery sourced from New Plymouth District Council GIS viewer.

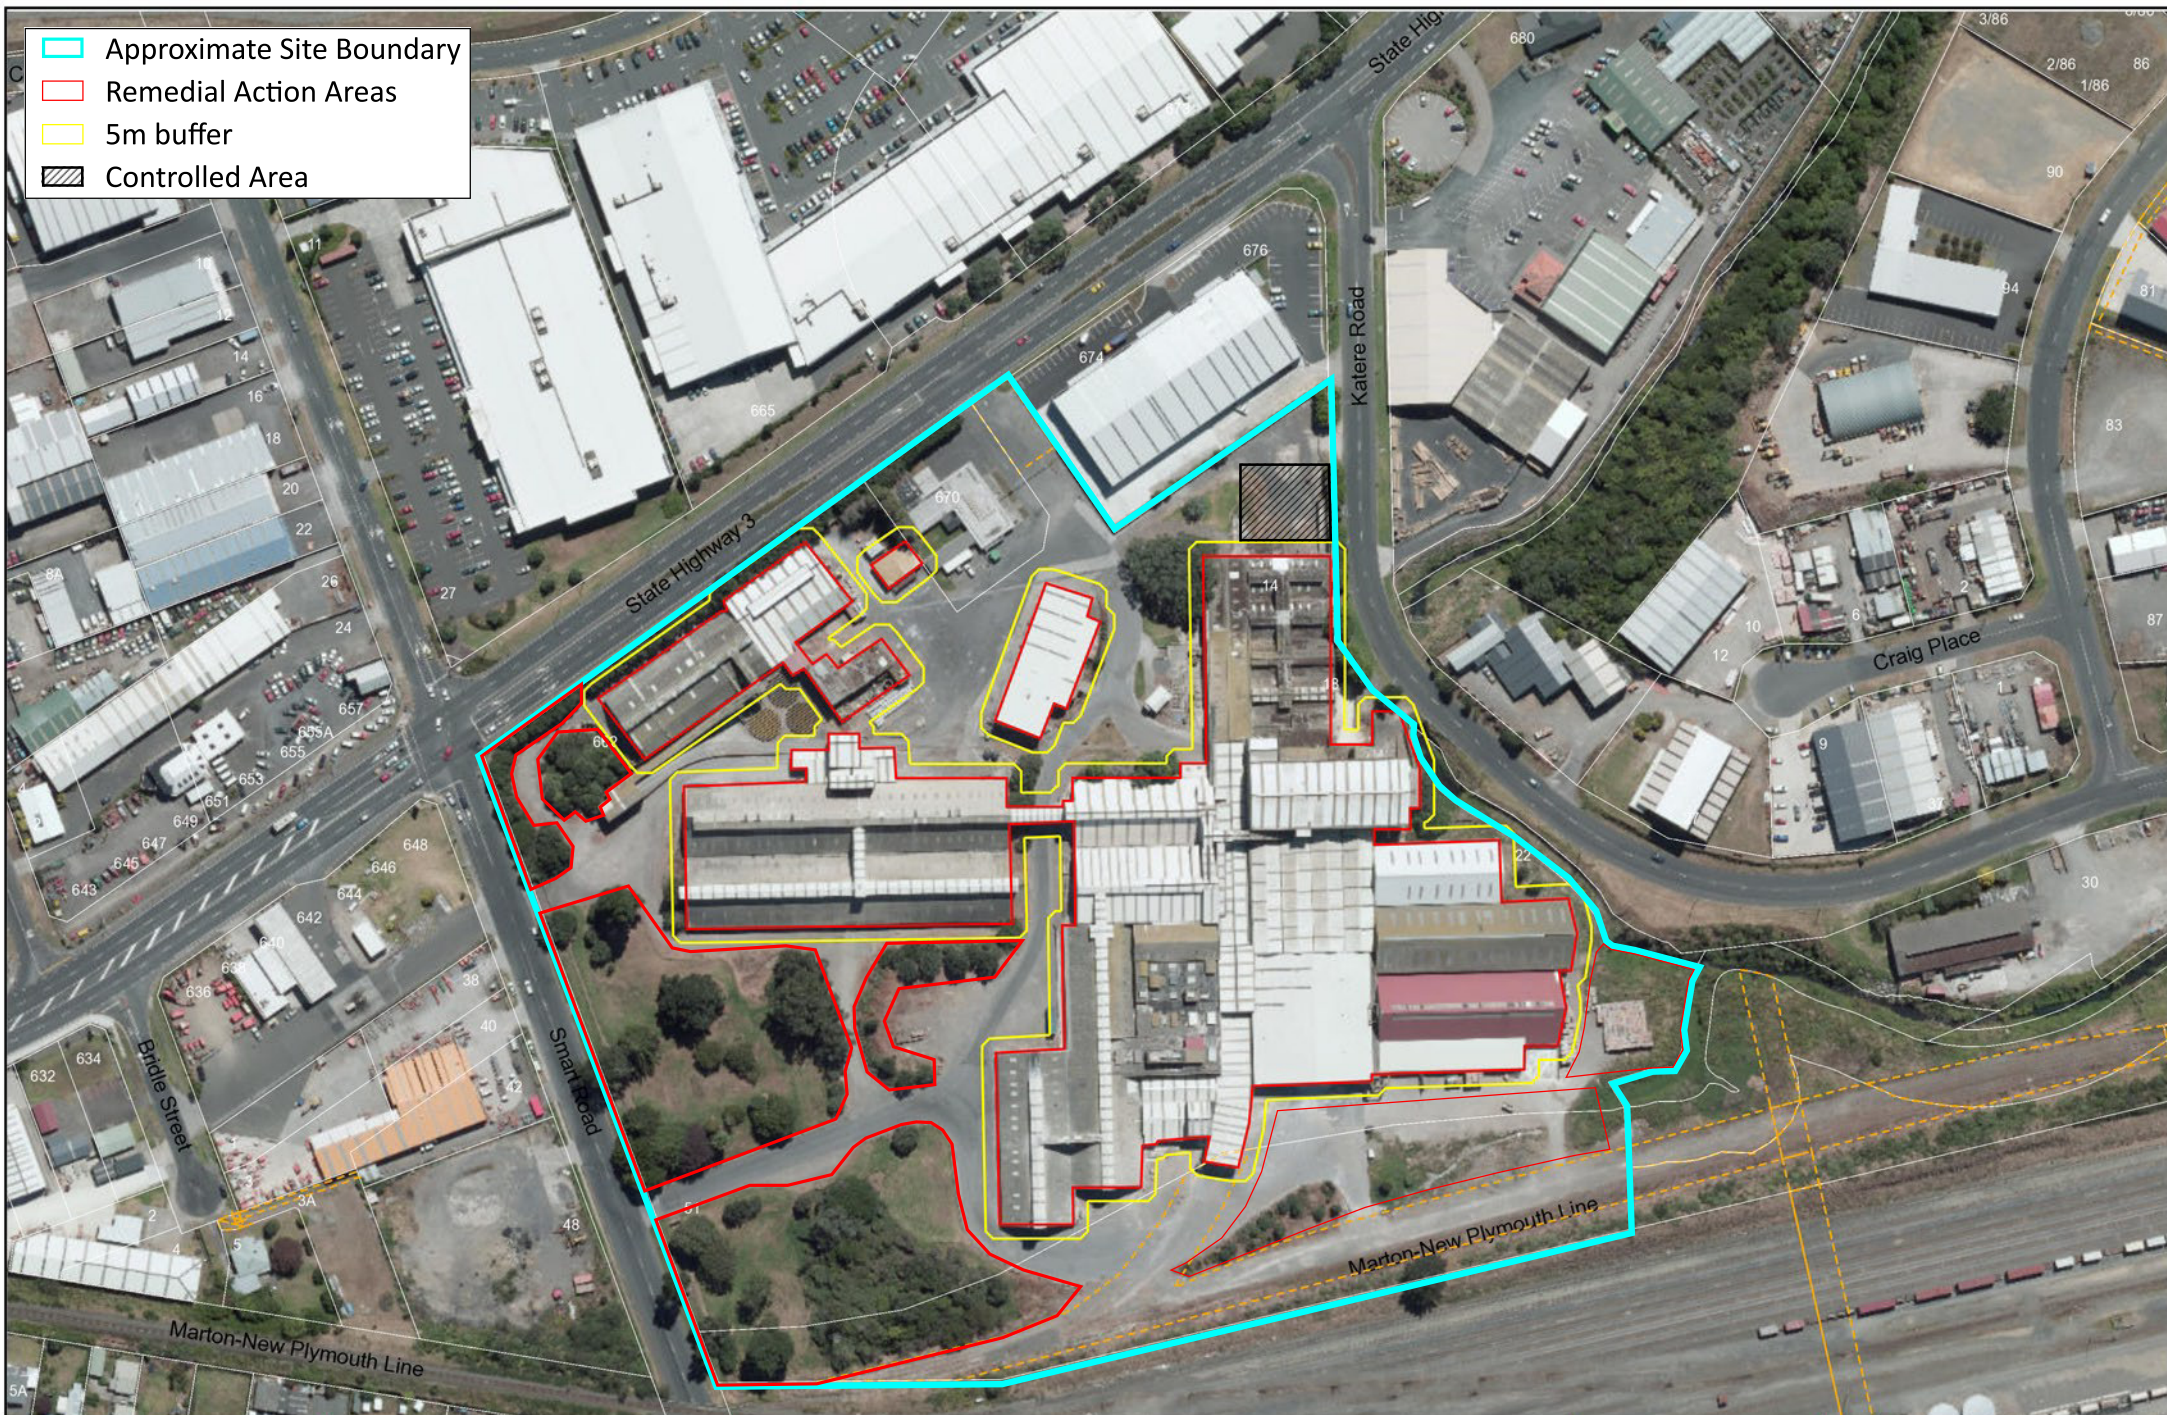
- Approximate Site Boundary
- Remedial Action Areas
- 5m buffer
- Controlled Area

Aerial imagery sourced from New Plymouth District Council GIS viewer.

Remedial action controls, such as stockpile management, erosion and sediment control, dust controls, worker health and safety precautions, and response to unexpected discovery of contamination are described in detail in the Contaminated Site Management Plan (CSMP).

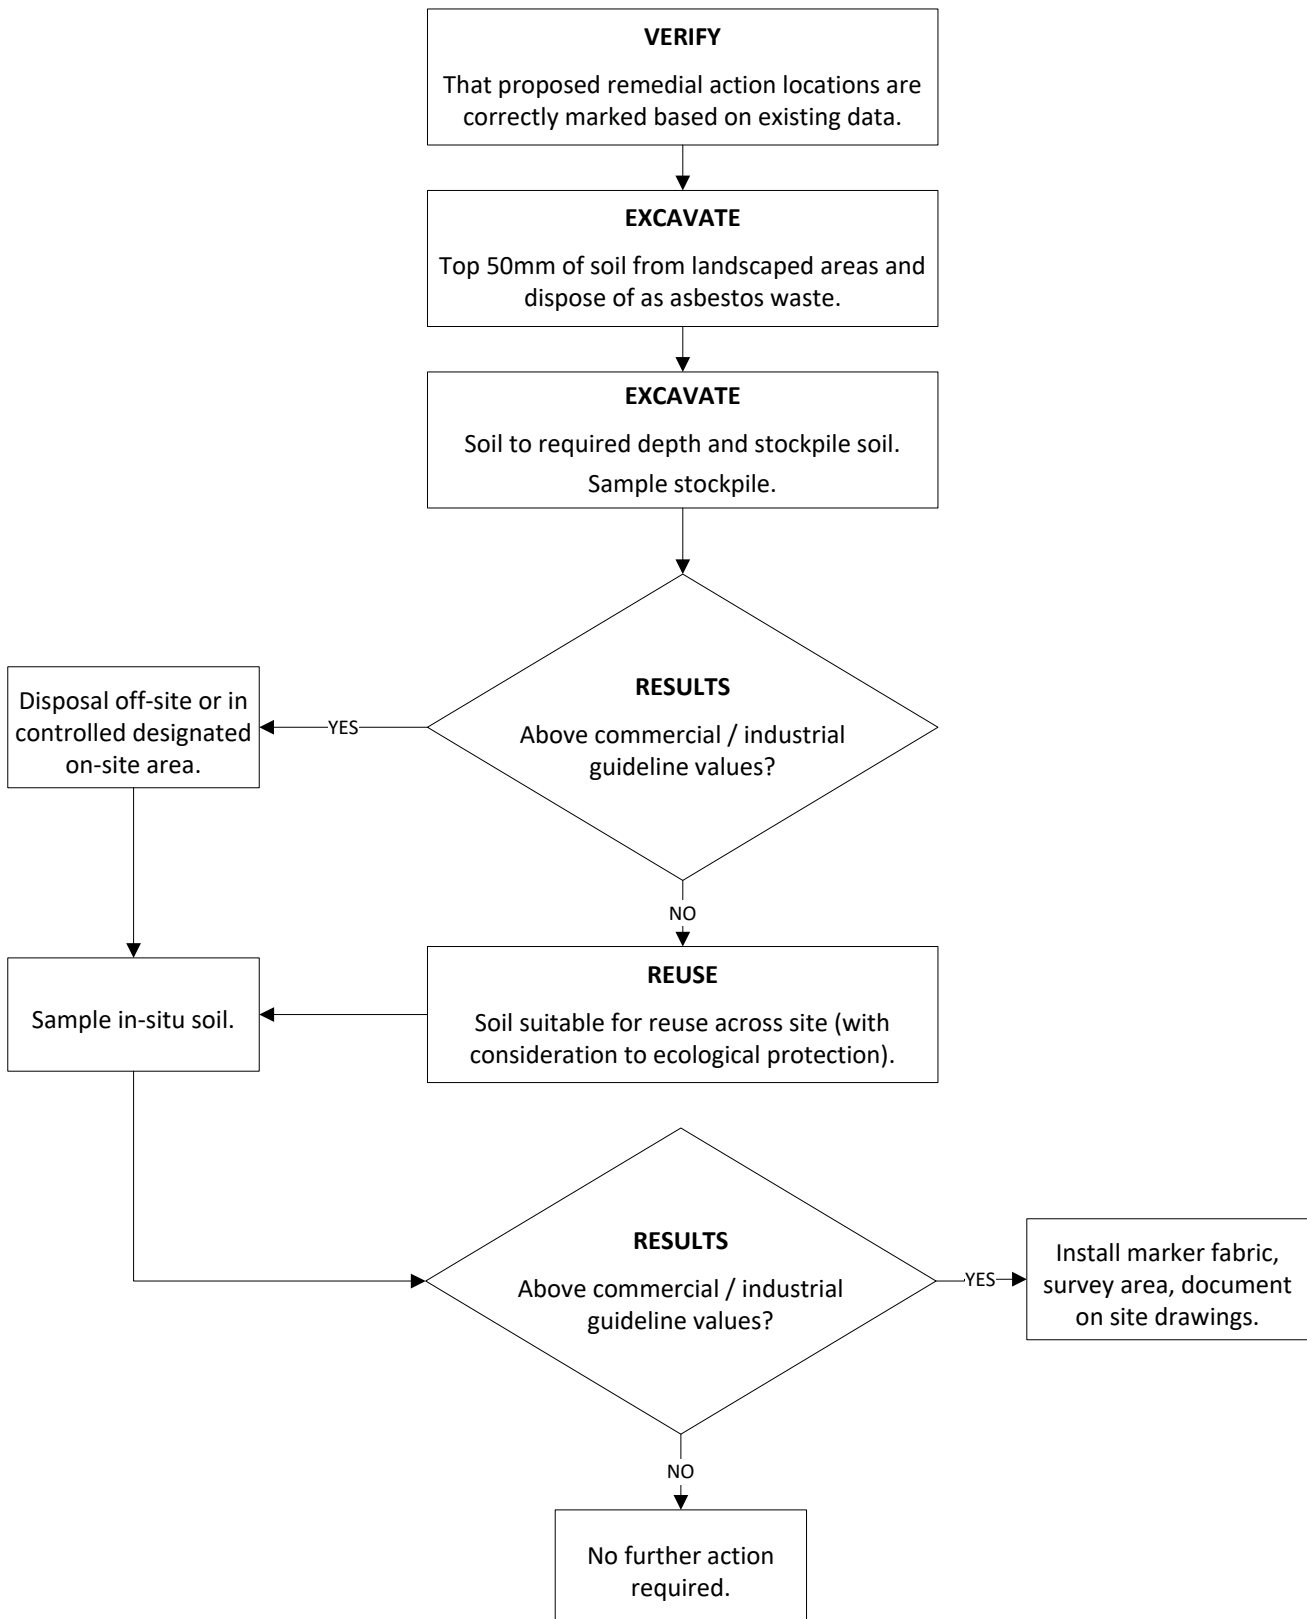
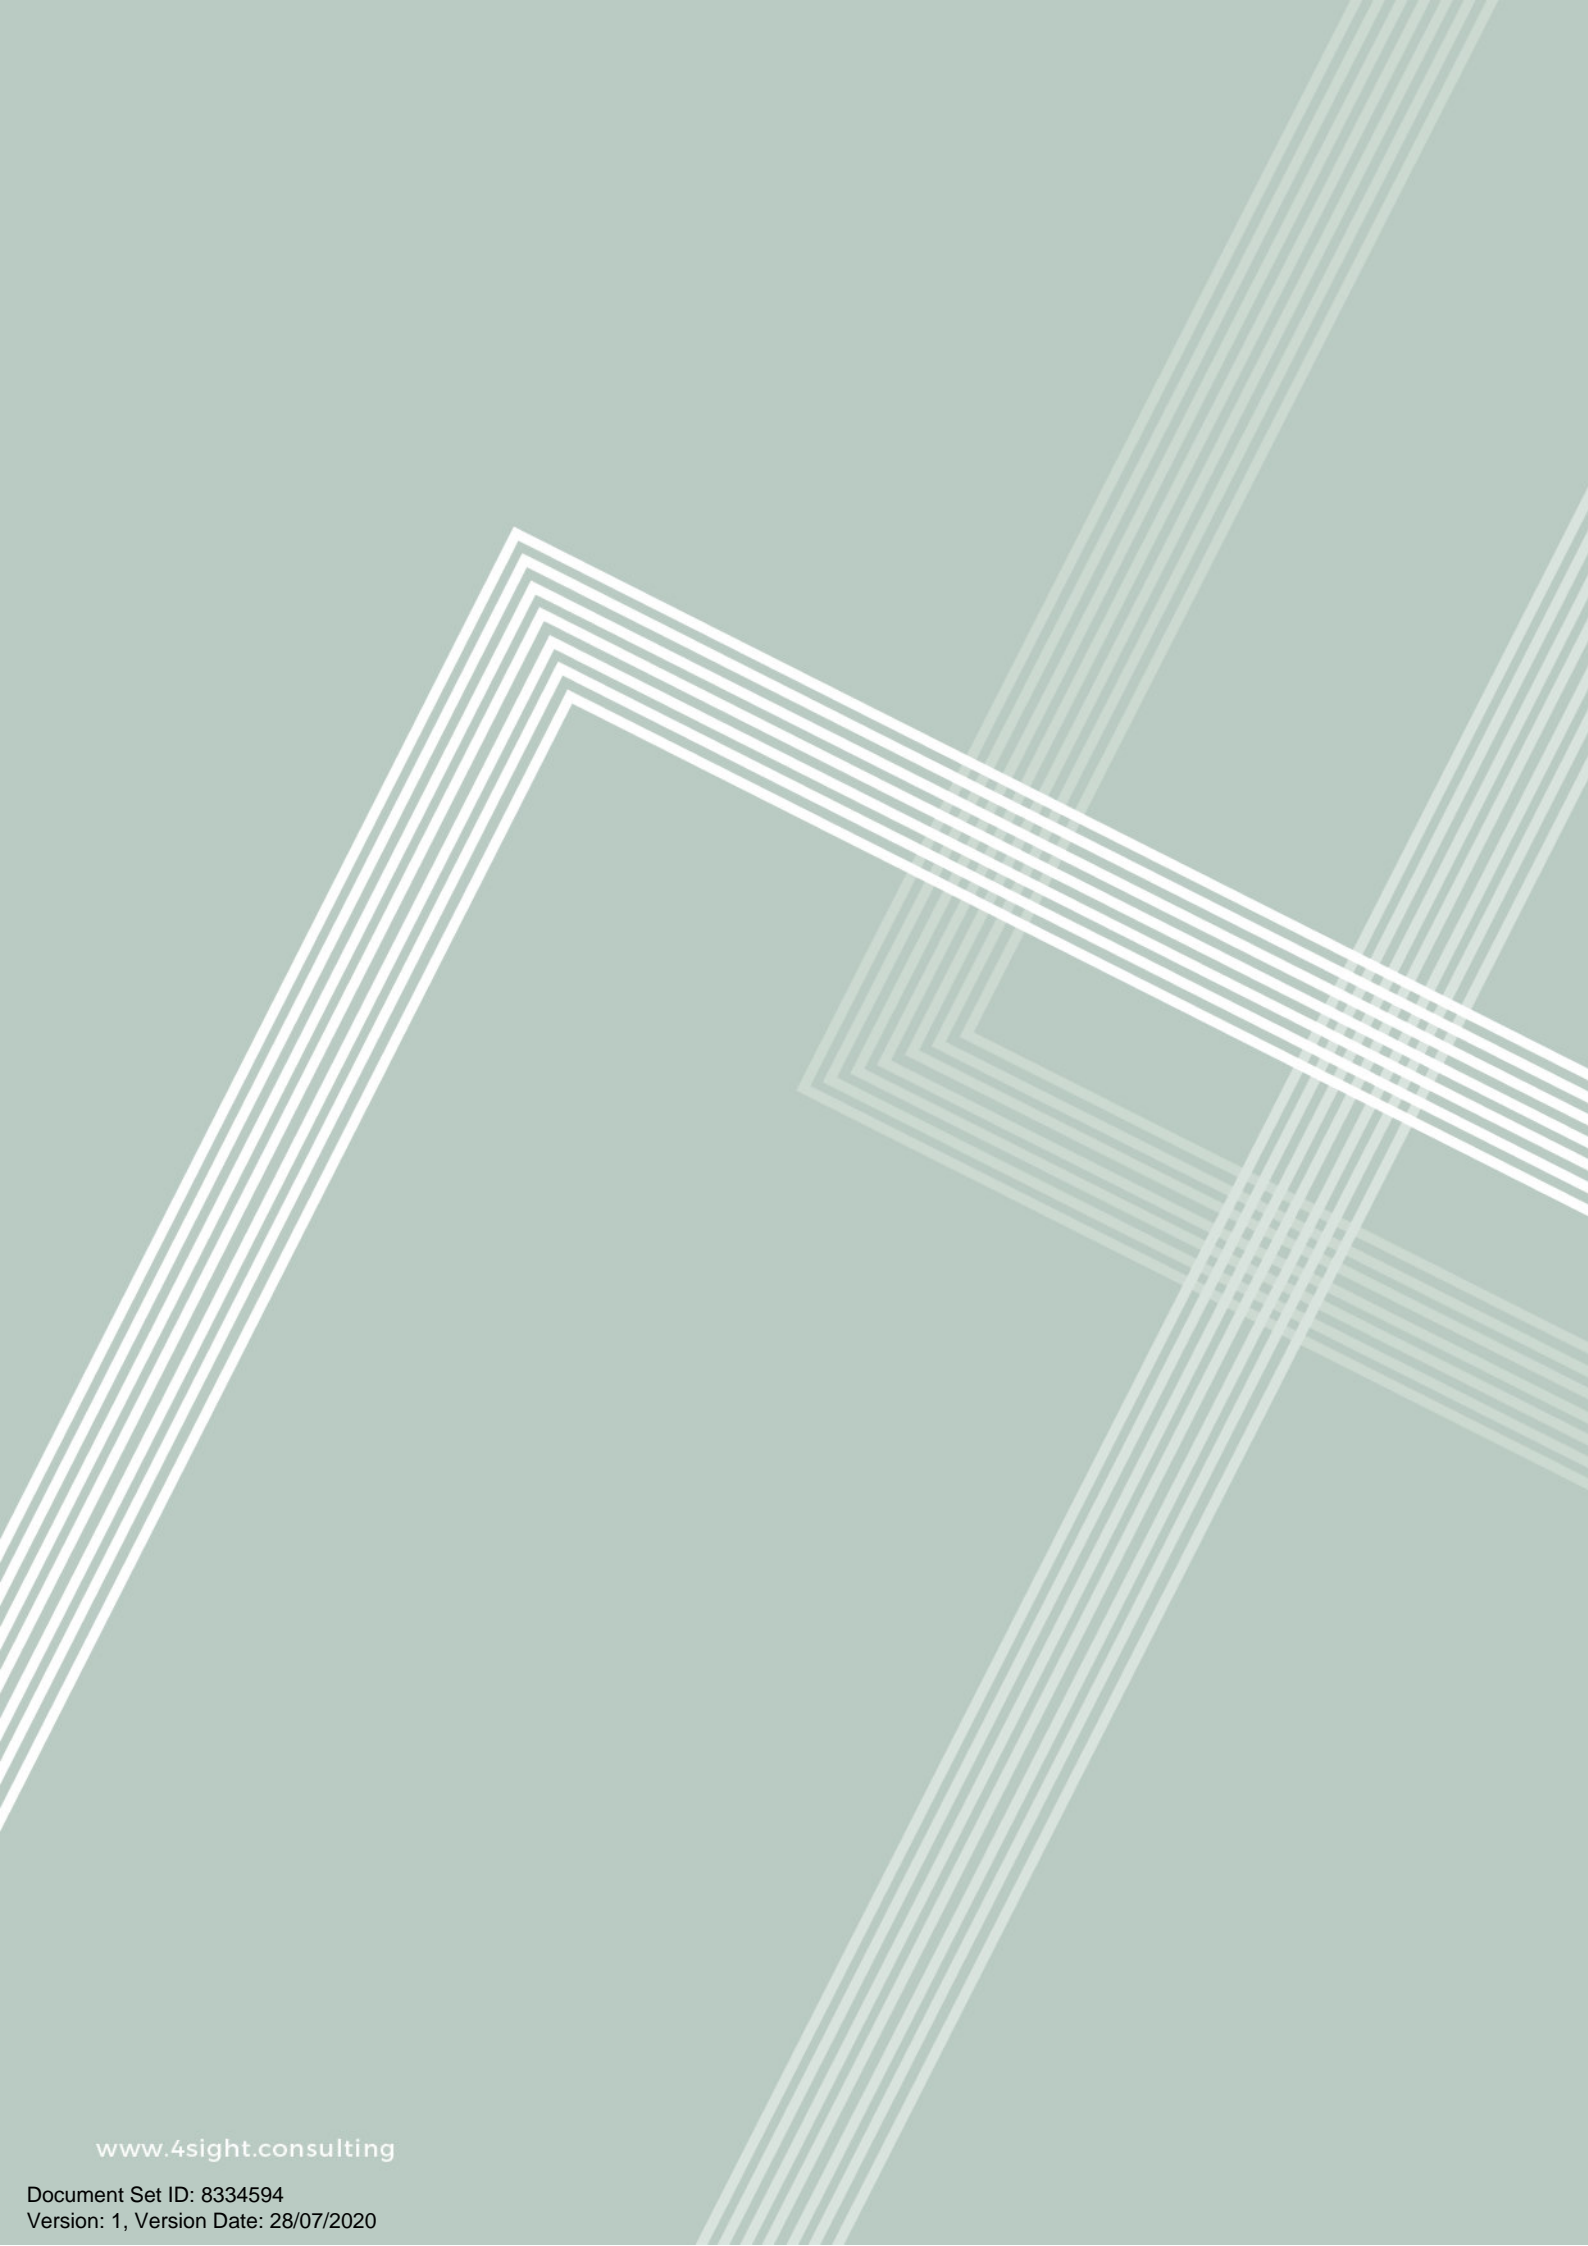
Remedial Action Flow Chart

PROPOSED REMEDIATION STRATEGY
