ENVIRONMENTAL REPORT

Preliminary Site Investigation, 1220
Devon Road, Bell Block, New
Plymouth

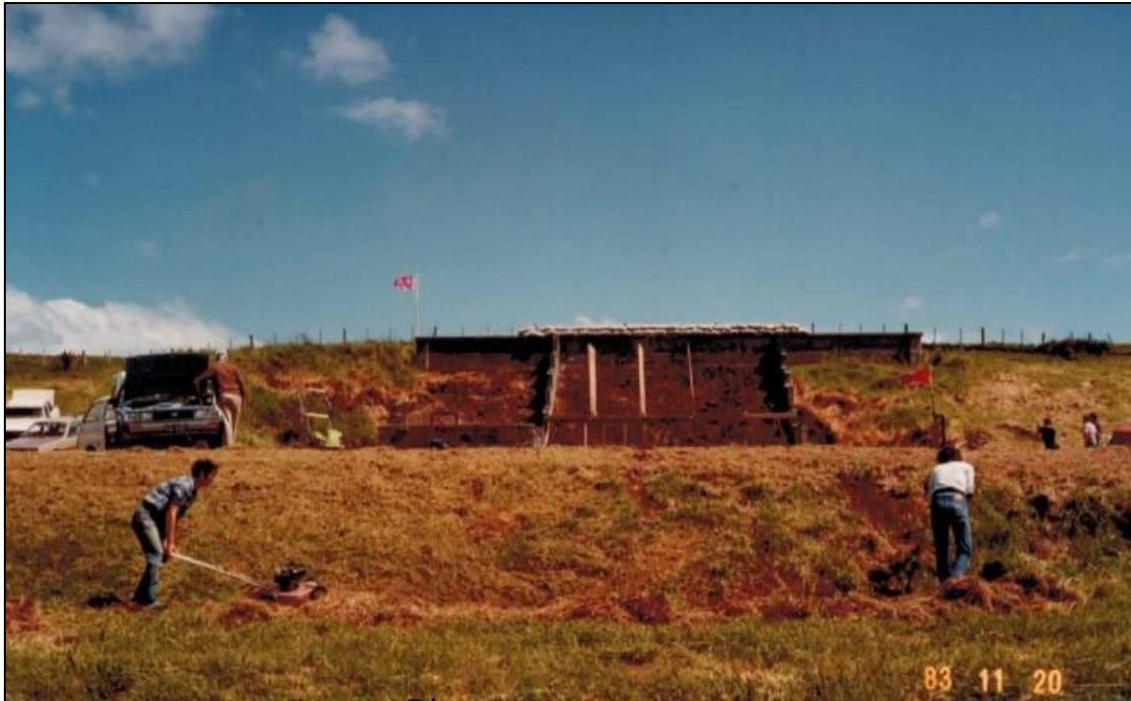
Figure 4.2: The machine gun range in 1983. Source: NPPC
