Archaeological Review

Mt Messenger Bypass

Historic Heritage Assessment

6 October 2017

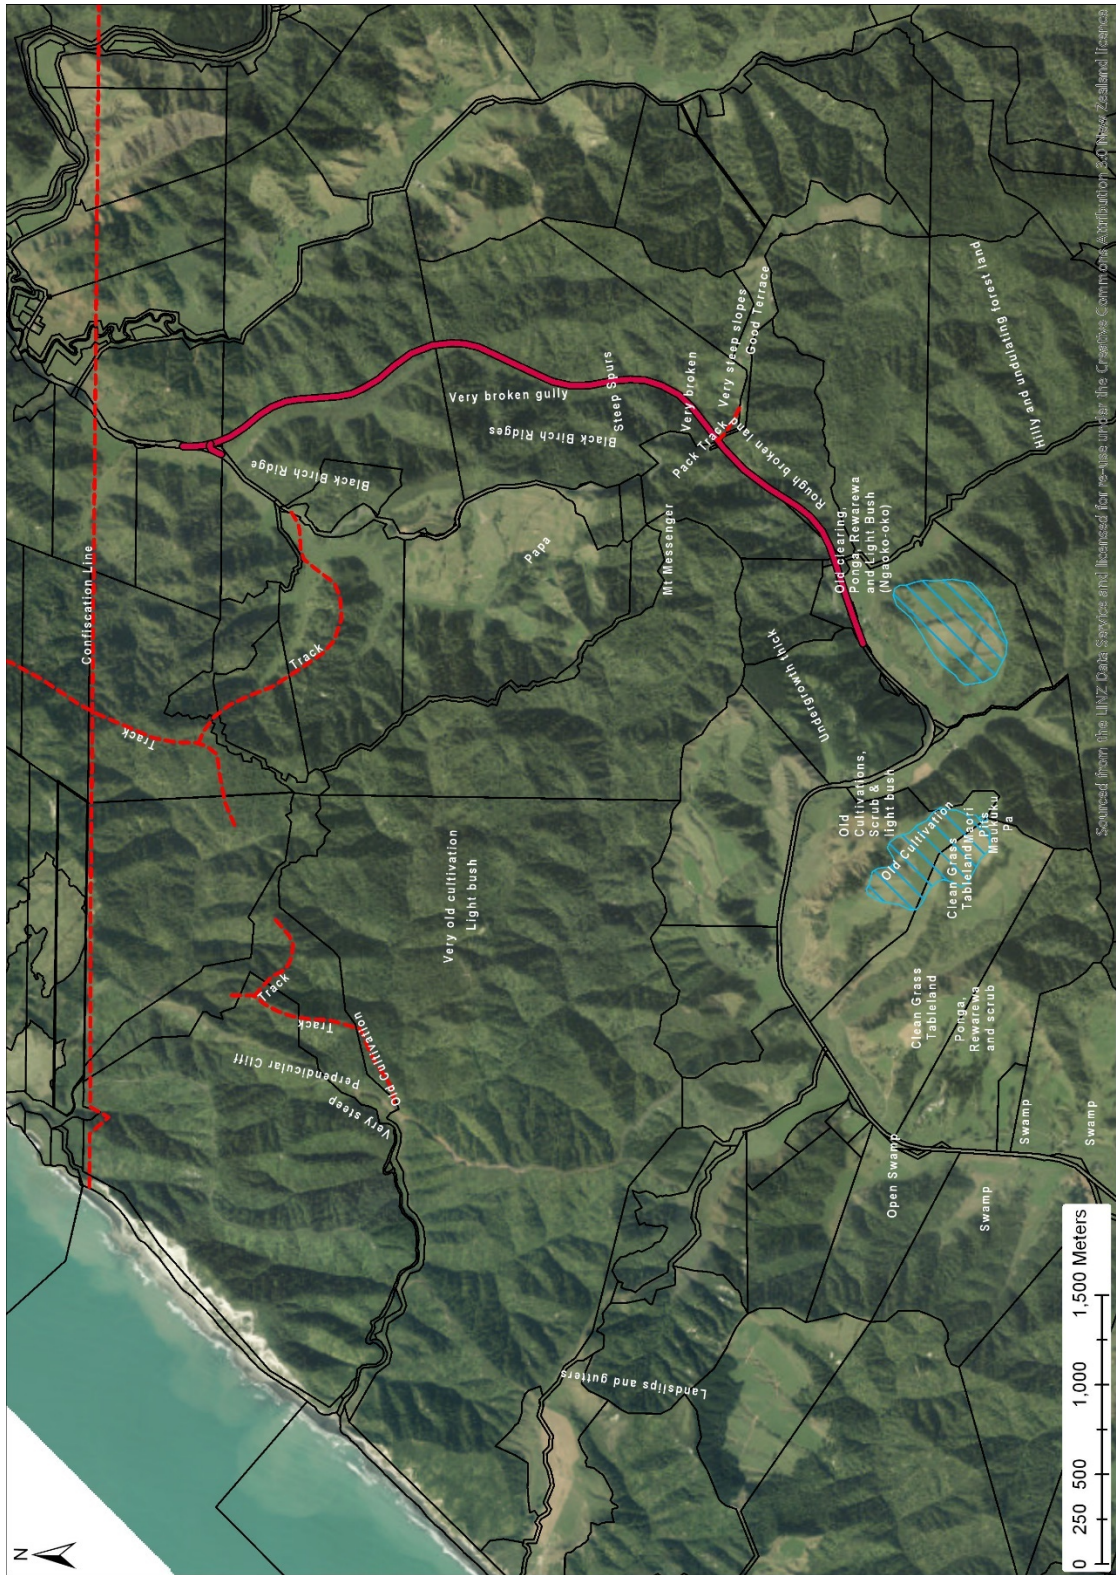
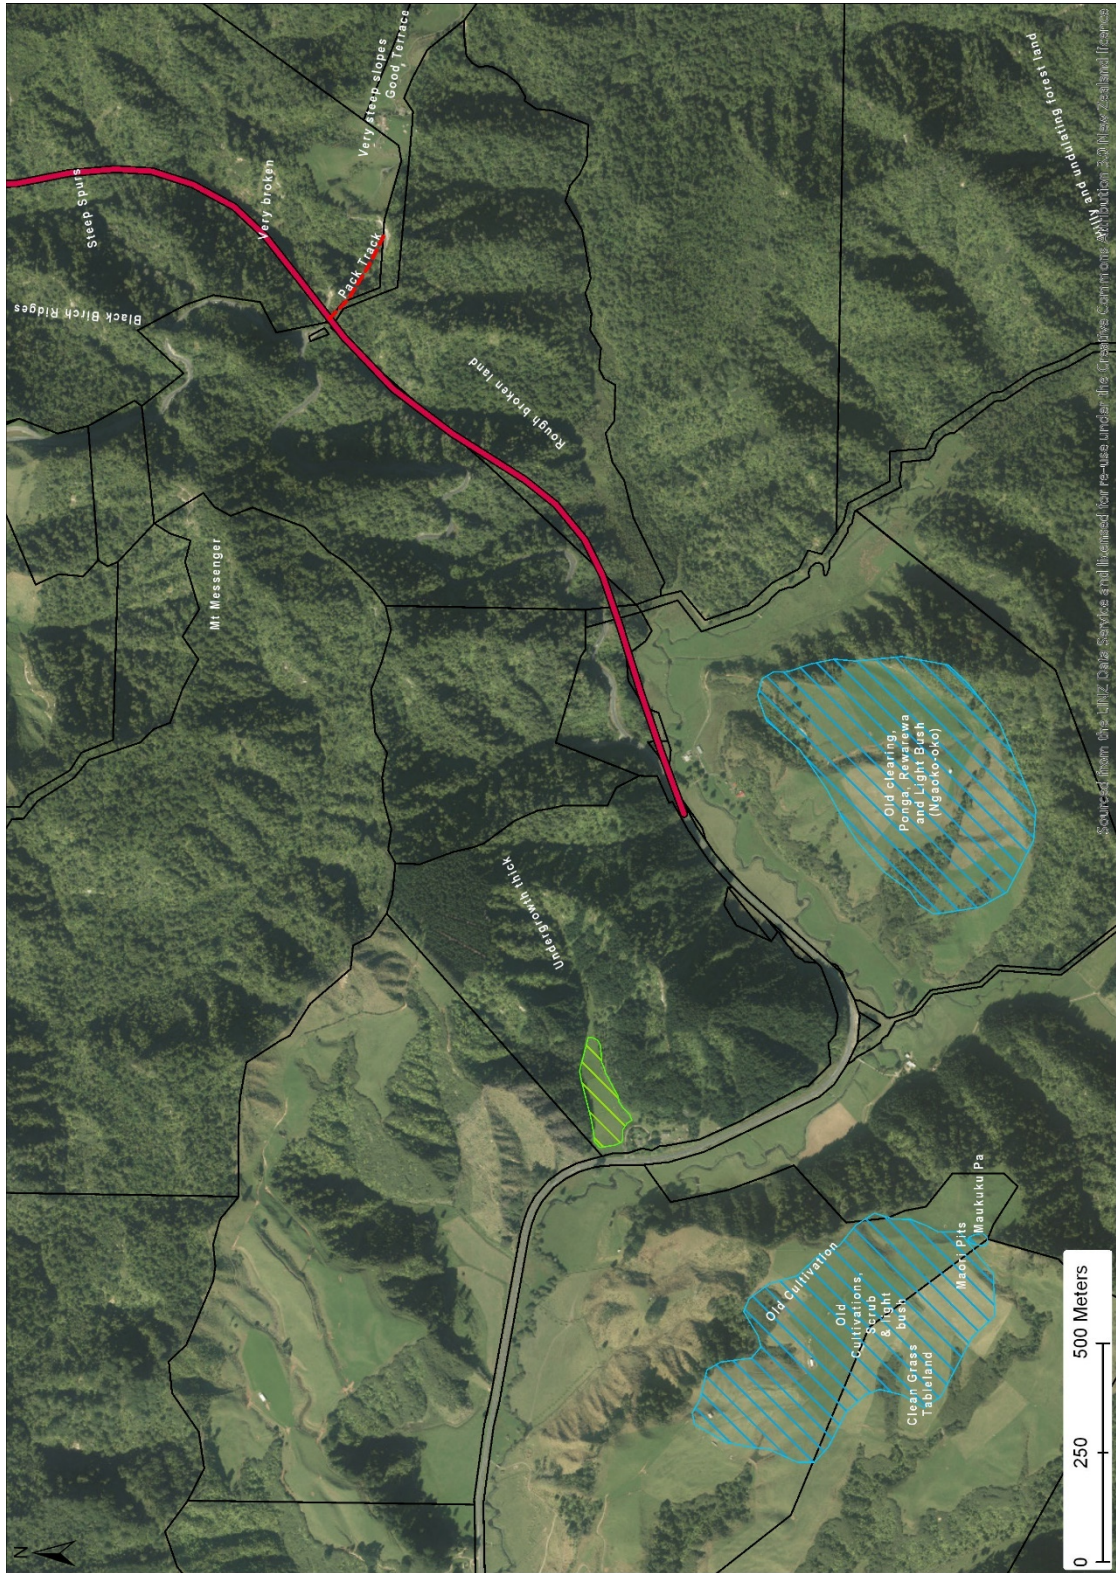
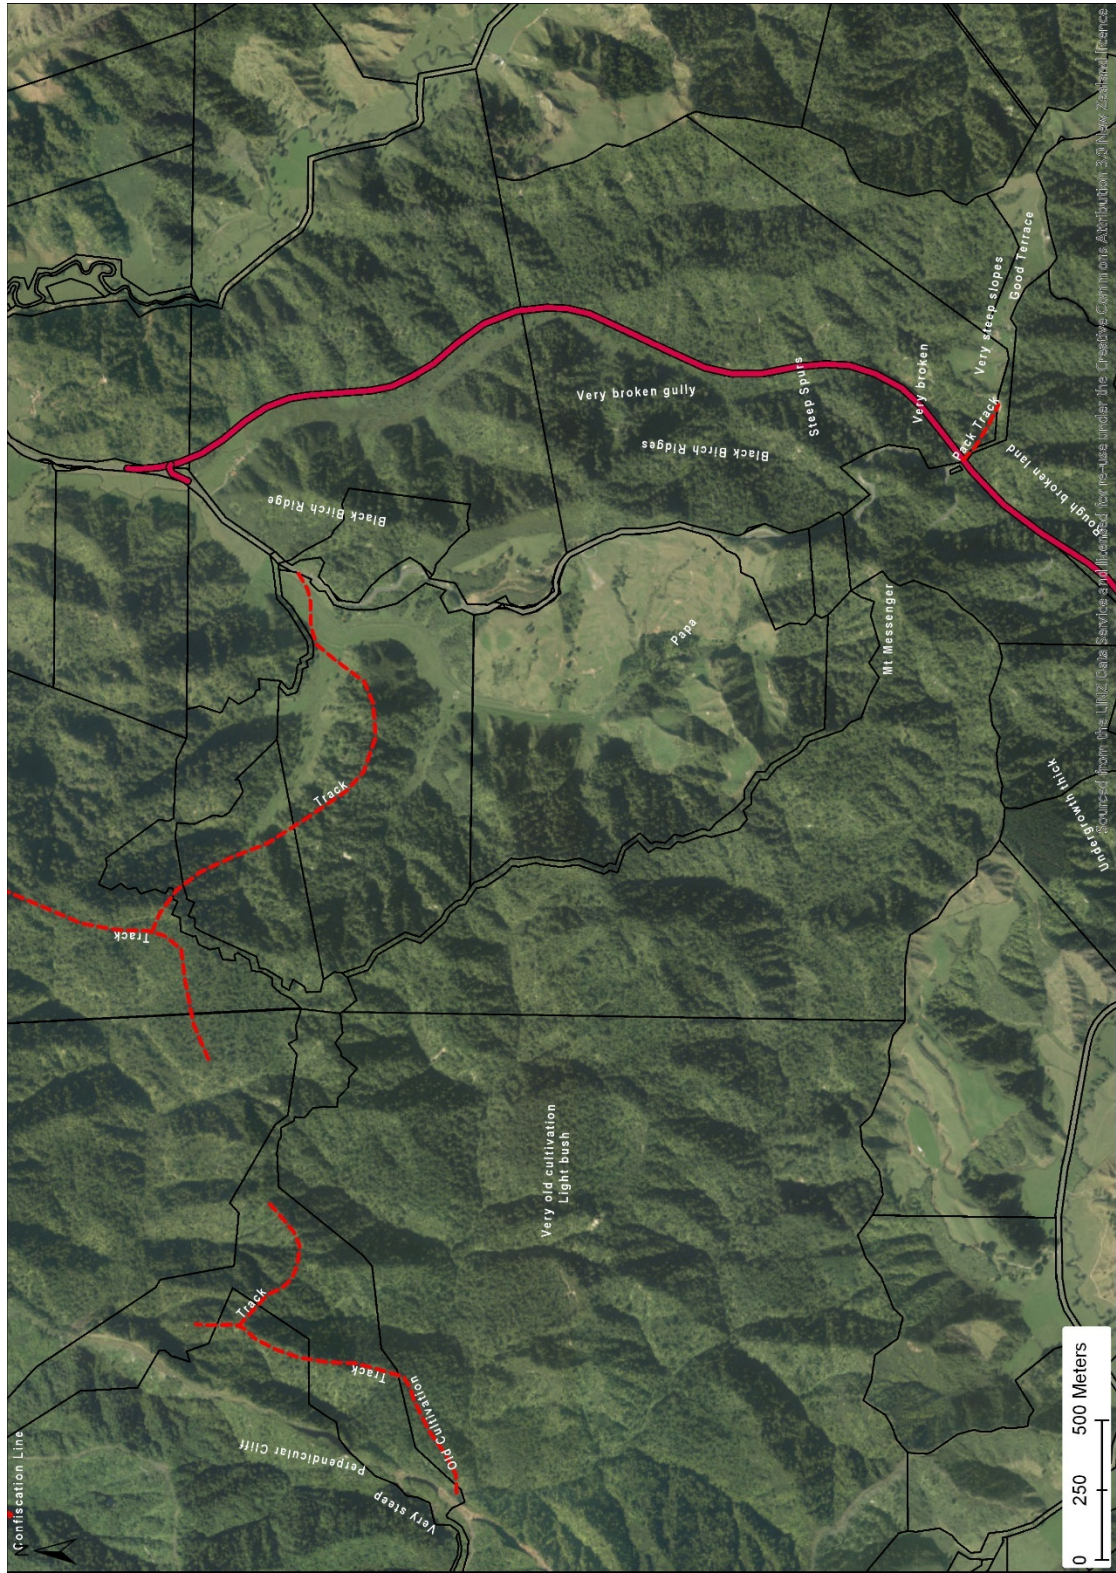
The sources examined by the HHA are comprehensive, covering all of the pertinent early survey plans (all c.1890-1900) for the immediate project area. In preparation of this review the various features of the historic survey maps were marked up in a GIS, to provide clarity regarding the relationship between noted features and the project area. This mark-up is detailed in Table 1 and Figure 5 - Figure 8, and is discussed below.

Figure 5: Plan showing location of information noted on historic survey plans

Figure 6: Plan showing location of information noted on historic survey plans for southern half of project area

Figure 7: Plan showing location of information noted on historic survey plans for northern half of project area

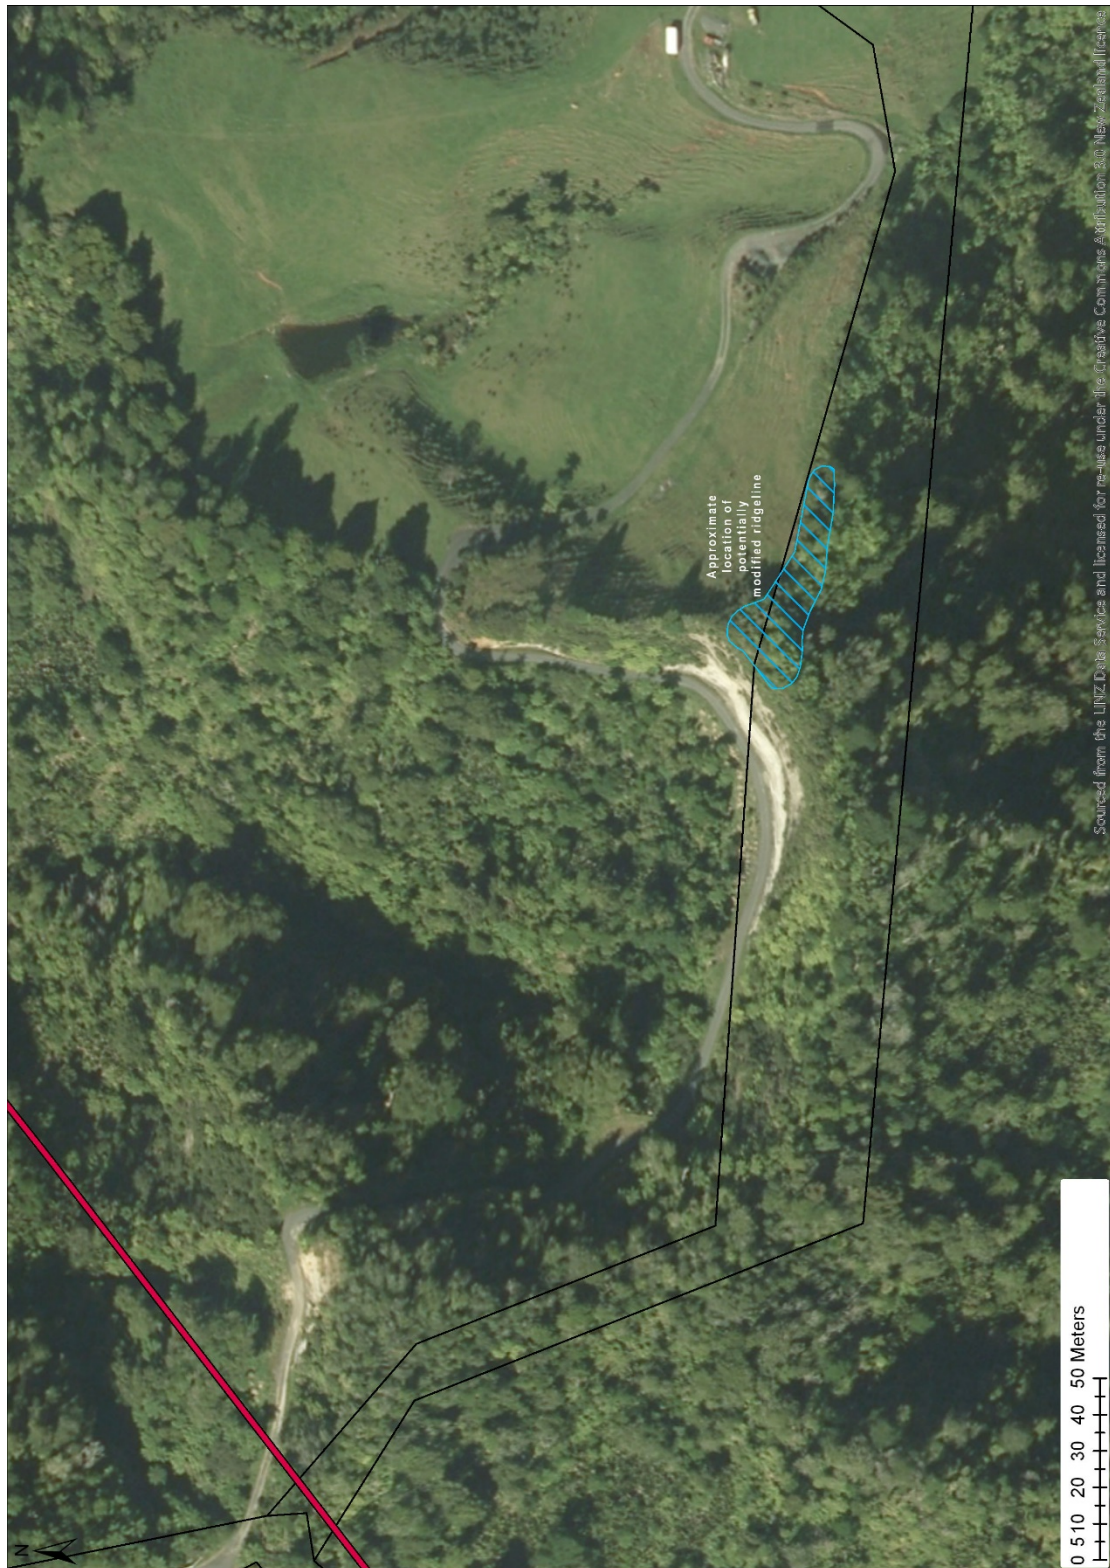
Similarly, site and time restrictions during the field visit for this review meant a comprehensive pedestrian survey was not possible. However, one area of possible concern was noted along the historic pack track from the rest area at the top of Mount Messenger (Figure 10). The ridgeline above the modern access road (originally the pack track) shows some evidence of anthropogenic modification.

Assuming that the historic pack track was originally a Maori ara (pathway) this location would have been suitable for either a small pa or defended sentry post, with exceptional natural defences and sight lines providing protection to the "good terraces" noted on SO 25/10 and SO 1969 (which were not examined during this review).

Figure 10: Possible pa site noted down pack track from Mount Messenger area

This location appears to be well enough removed from any works related to the proposed bypass route to be of no great concern, but the HHA should address any potential implications for this site, if it does turn out to be a pa upon further inspection.

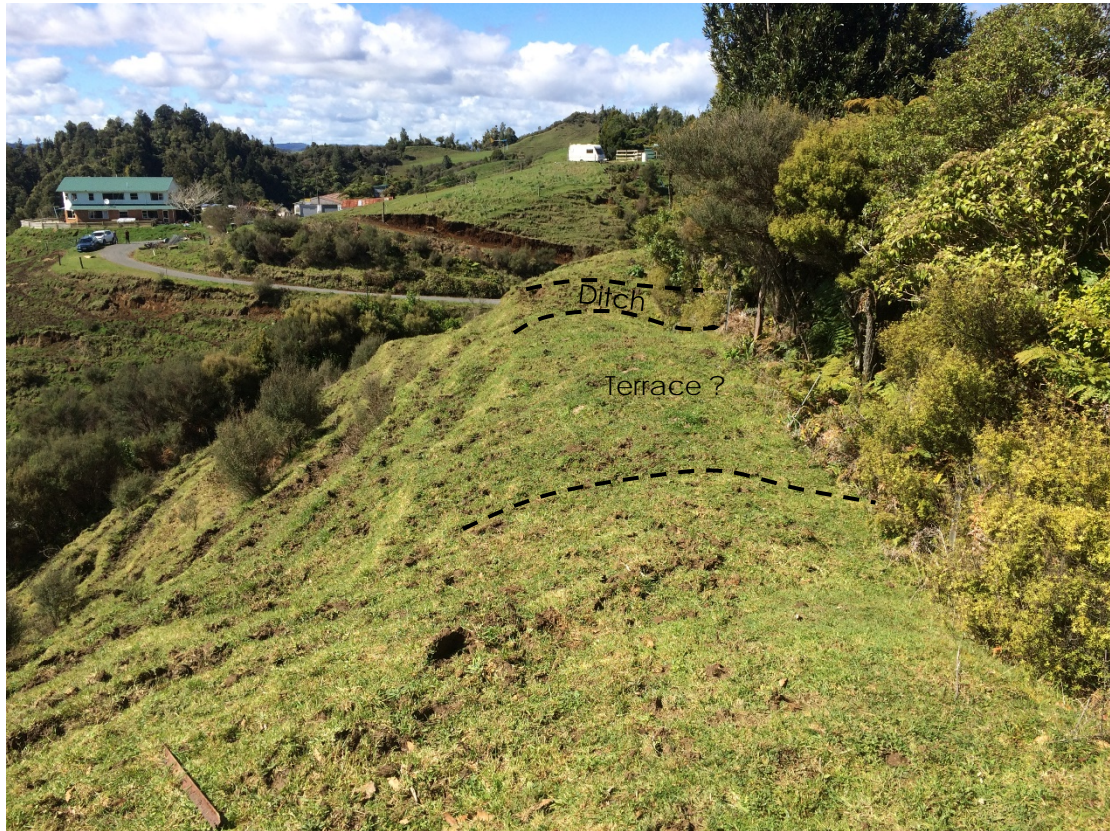
The top of this ridgeline exhibits signs of terracing and two possible transverse defensive ditches (Figure 11 - Figure 13) which may indicate an unrecorded archaeological site. The features are smoothed and amorphous in form and may be naturally occurring geomorphological features, although the ditches are comparable to eroded ditches commonly found on archaeological sites elsewhere in North Taranaki. This ridgeline has been grazed by cattle and the ground surface has been heavily disturbed.

Thick bush covers the southern half of the site as well as the ridgeline beyond the western ditch, but due to time constraints during the site visit these areas could not be examined in detail, so the nature of the features could not be conclusively determined. It is unclear whether this area was examined during the HHA and discounted as being archaeological but if not, it would warrant further investigation. This location is one of the highest points east of Mount Messenger, providing an exceptional viewshed down the Mangapepeke valley to the north and the Mimi valley to the south, across the Mount Taranaki. These views are approximated through Google Earth in Figure 14 and Figure 15, but do not take into account that the area was heavily forested throughout most of history and prehistory.

Figure 11: Photograph looking east along possibly modified ridgeline above access road from rest area.

1. The northern-most property and southern fill site needs to be fully assessed.
2. The heritage values of the original burnt-papa road, Mount Messenger tunnel, papa kilns and papa quarries should be assessed and mitigation discussed.
3. A wider landscape view should be considered when assessing the likelihood of encountering unrecorded archaeological sites in the project area. The HHA determines the landscape to be unsuitable for occupation, but other similar landscapes in North Taranaki are well populated with archaeological sites.
4. A potential site above the pack track from the Mount Messenger rest area should be investigated further.

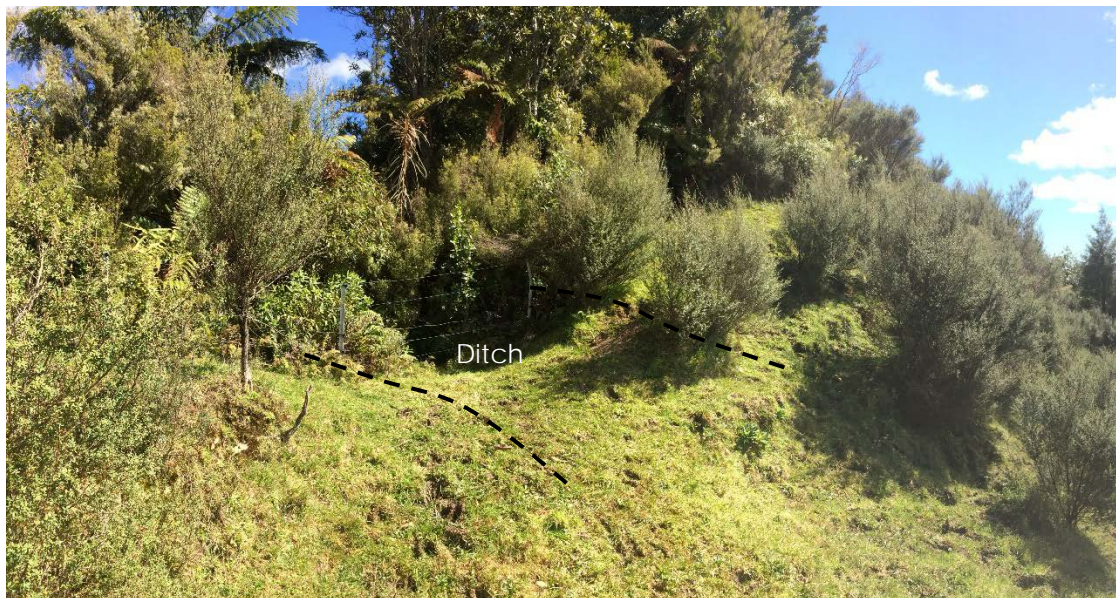
Figure 12: Photograph looking west at possible ditch on ridgeline, above access road from rest area.

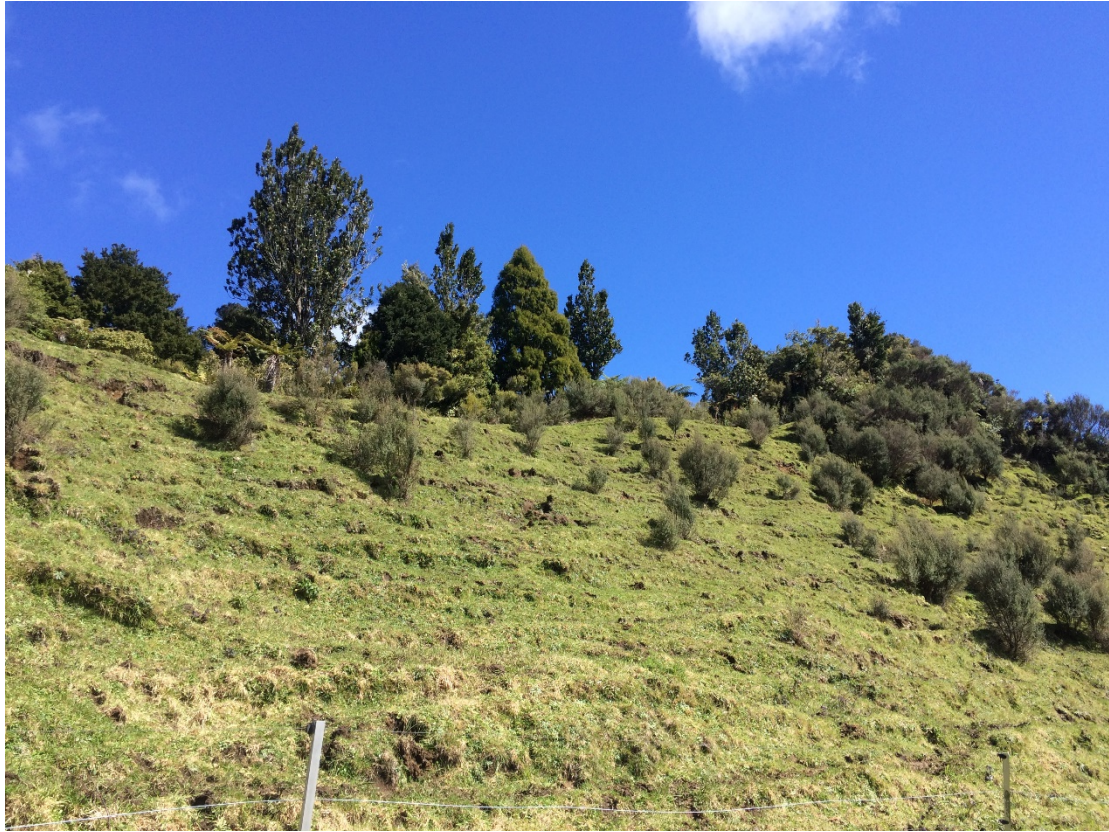
Figure 13: Photograph looking south, up from access track to possibly modified ridgeline
